Proposed Large Scale Residential Development,
Ross Rd., Killarney, Kerry.

Quality Audit Report

Client	Homeland Group
Project Title	Proposed Large-Scale Residential Development
Project Location	Ross Rd., Killarney, Kerry
Document Title	Quality Audit Report
Document No.	25012TT-MHL-Ross Rd.Killarney LRD-Doc02-QAR
Job No.	25012TT

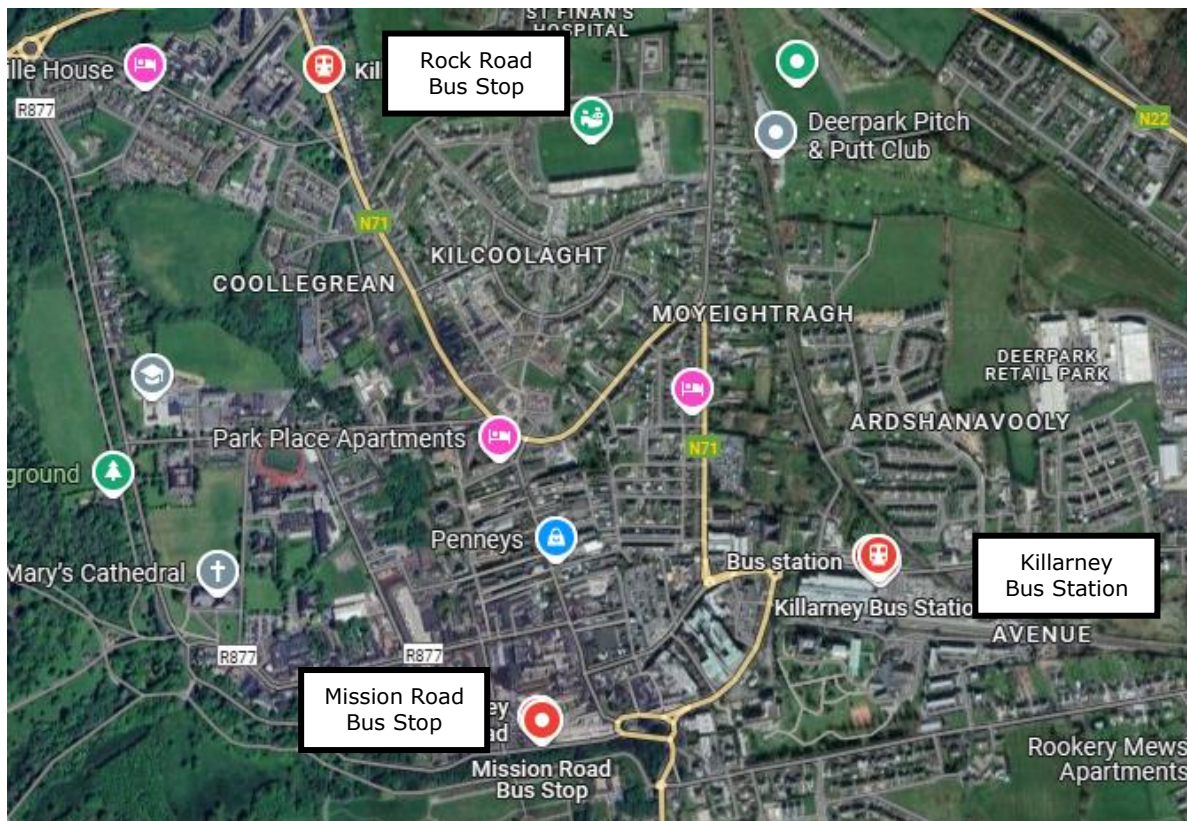
Figure 3.8 Bus Stop closest to the proposed site at Ross Road.

On the day of the site visit pedestrian numbers were moderate, and there were some cyclists observed in the area. The intended residential development in the area is likely to significantly increase pedestrian and cycle numbers locally. There is one bus stop for the Dublin bus on the Mission Road at Least 1km from the proposed development access. The

closest bus stop for Bus Eireann would be the bus station in Killarney which is approximately 2km from the site.

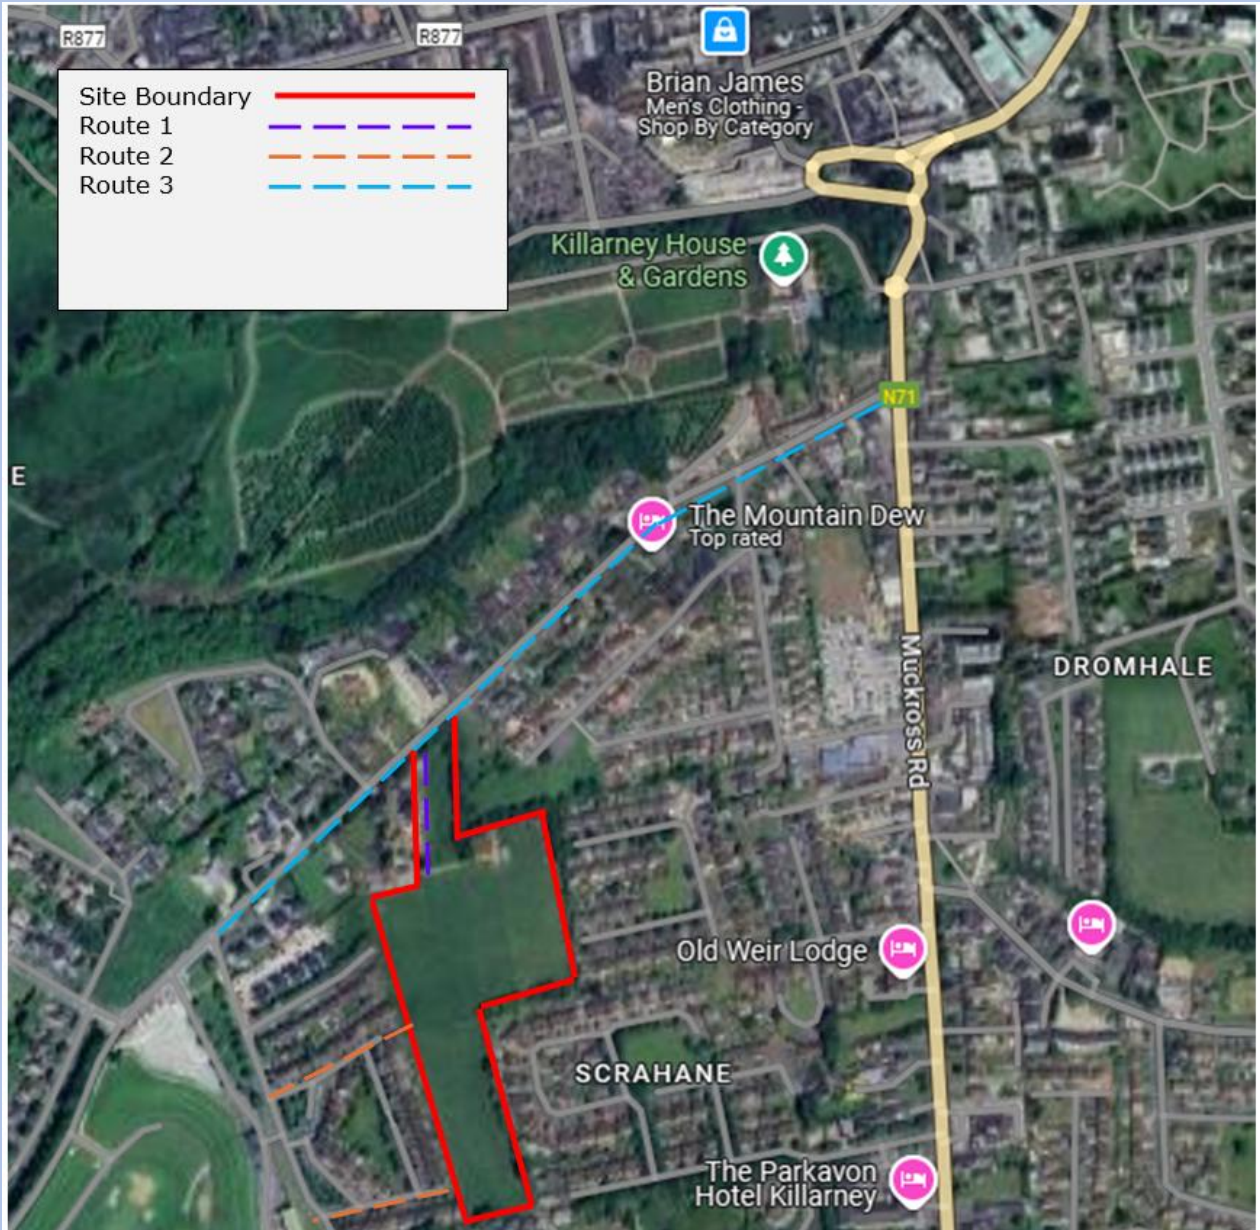
The development's access road is a carriageway of approximately 6m width as far as the junction with the Ross Road where a short. A 2m wide footpath runs along the southern extent of the ross road to within approximately 50m short of the proposed development entrance. Another 1.5 to 2m wide footpath is provided on the norther side if Ross Road.

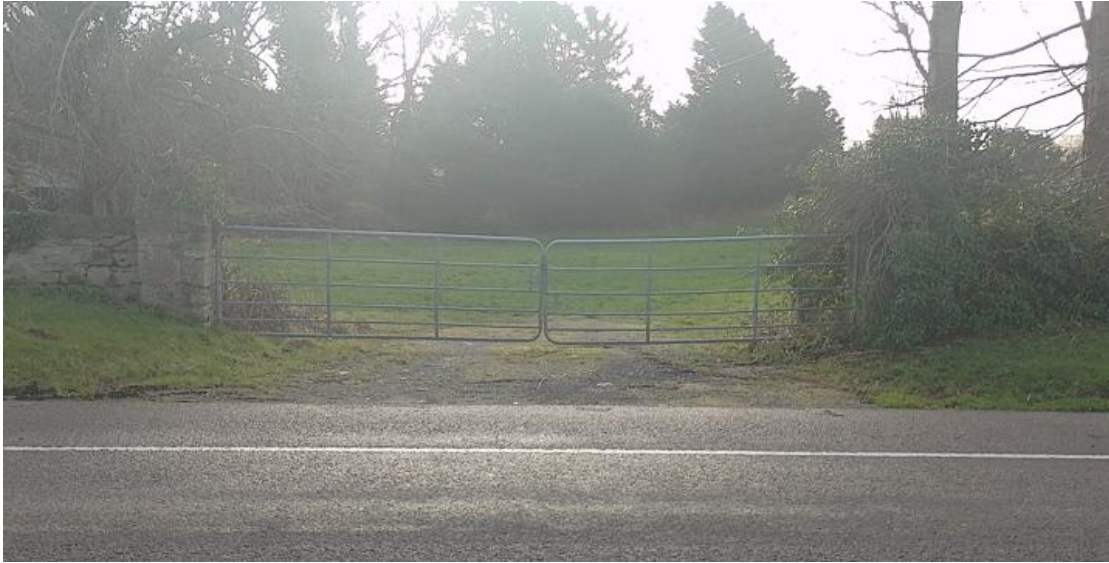
Figure 6.1 Photo Direction A

Issue: there is no footpath along the entrance of the site. Pedestrians will be unable to walk along Ross Road unless they cross the road where there is oncoming traffic. The nearest pedestrian crossing is at the Killarney Racecourse. This would involve pedestrian walking along the public road and could result in pedestrians being involved in a collision with a vehicle.

Recommendation: Provide a crossing and continuous footpath along the southern side of Ross road as proposed as part of this development. Ensure that all crossings incorporate either dropped kerbs or raised crossing tables to ensure that vulnerable road users are accommodated.

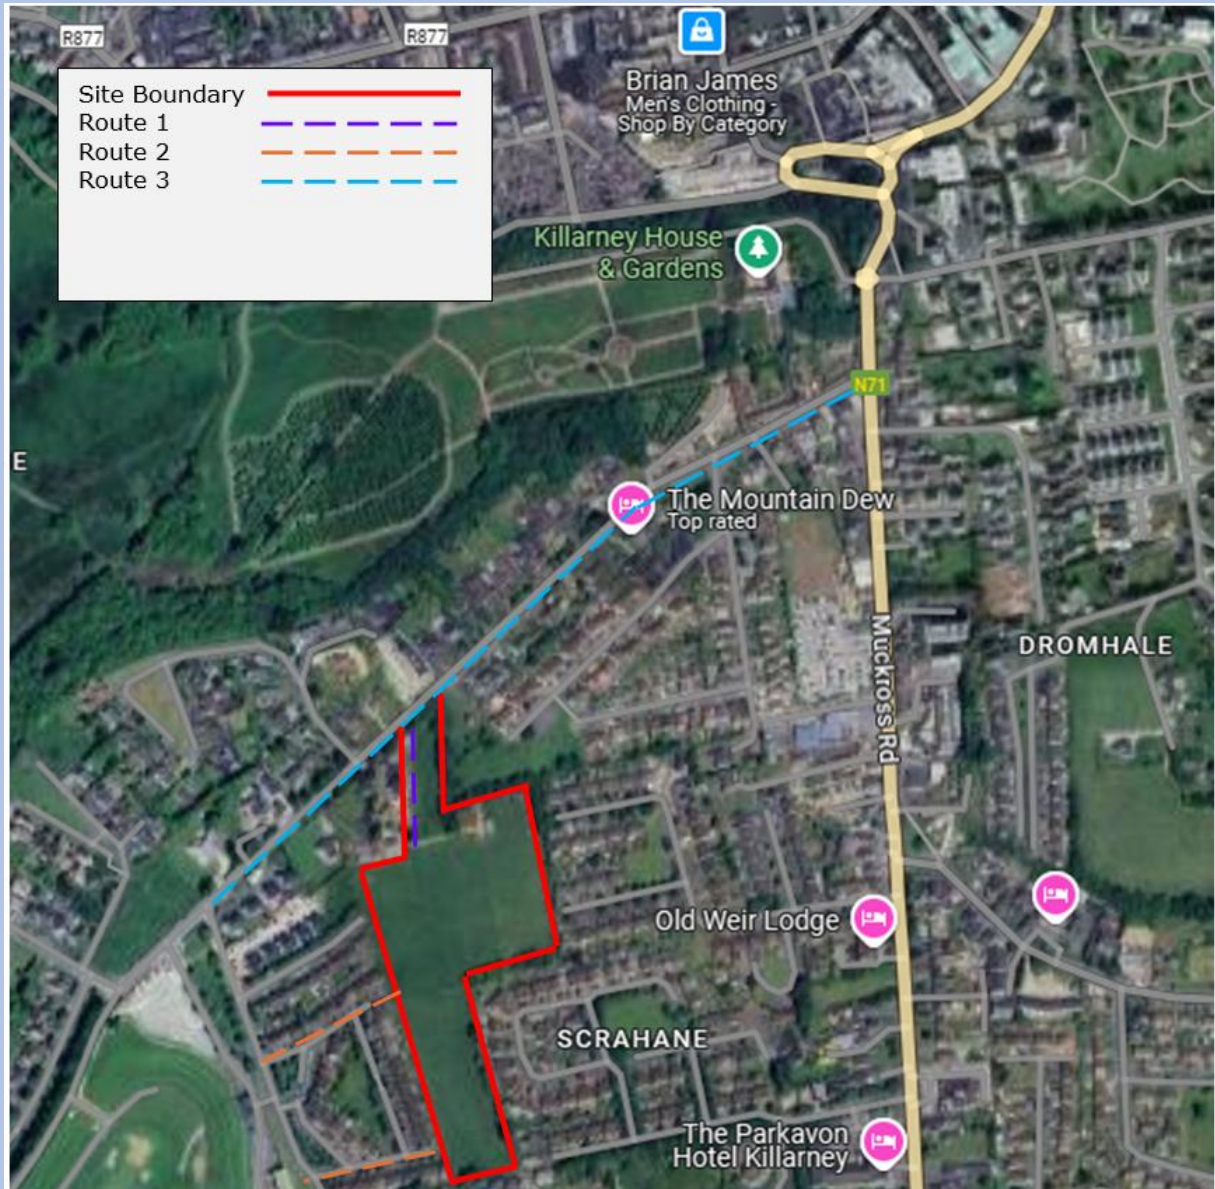
Castle Falls Estate has an access footpath of approximately 2m wide. This footpath connects pedestrians from the front door to the Flesk Cycle & Walking Facility and onwards to Ross Road. Crossing the Ross Road will be facilitated by the existing controlled Toucan crossing. This new section of the shared facility for both Pedestrians and Cyclists have recently be constructed by Kery Co Co as part the Flesk Cycle & Walking Facility.

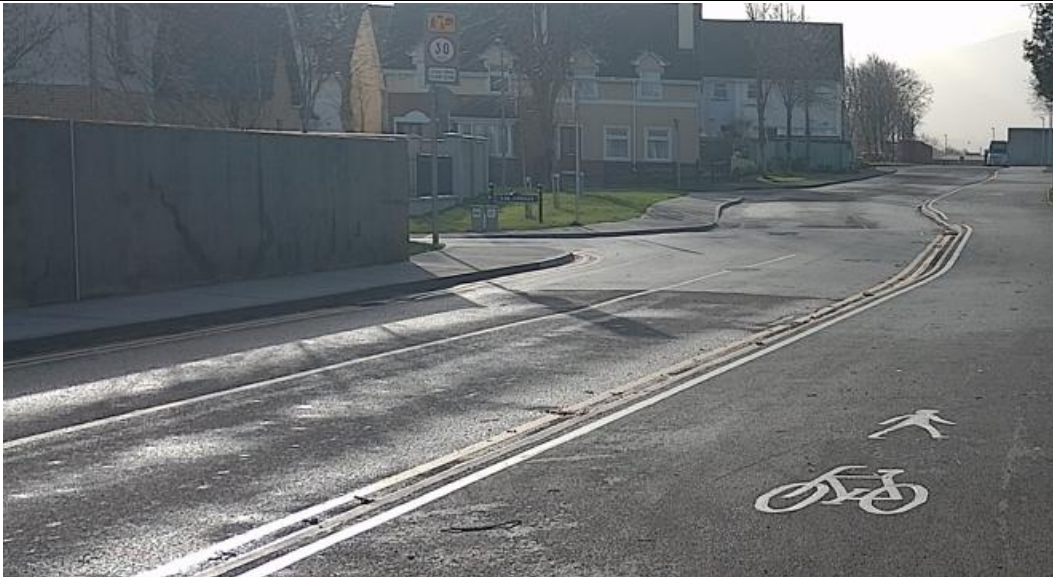
Figure 7.1 Photo Direction B

Issue: Pedestrian connectivity restricted due to no crossing, drop kerbs or tactile paving provided. Unregulated pedestrian crossings could lead to collision, injury with passing traffic.

Recommendation: Appropriate uncontrolled pedestrian crossing facilities to be provided at links between Castle falls & the Flesk Cycle & Walking Facility

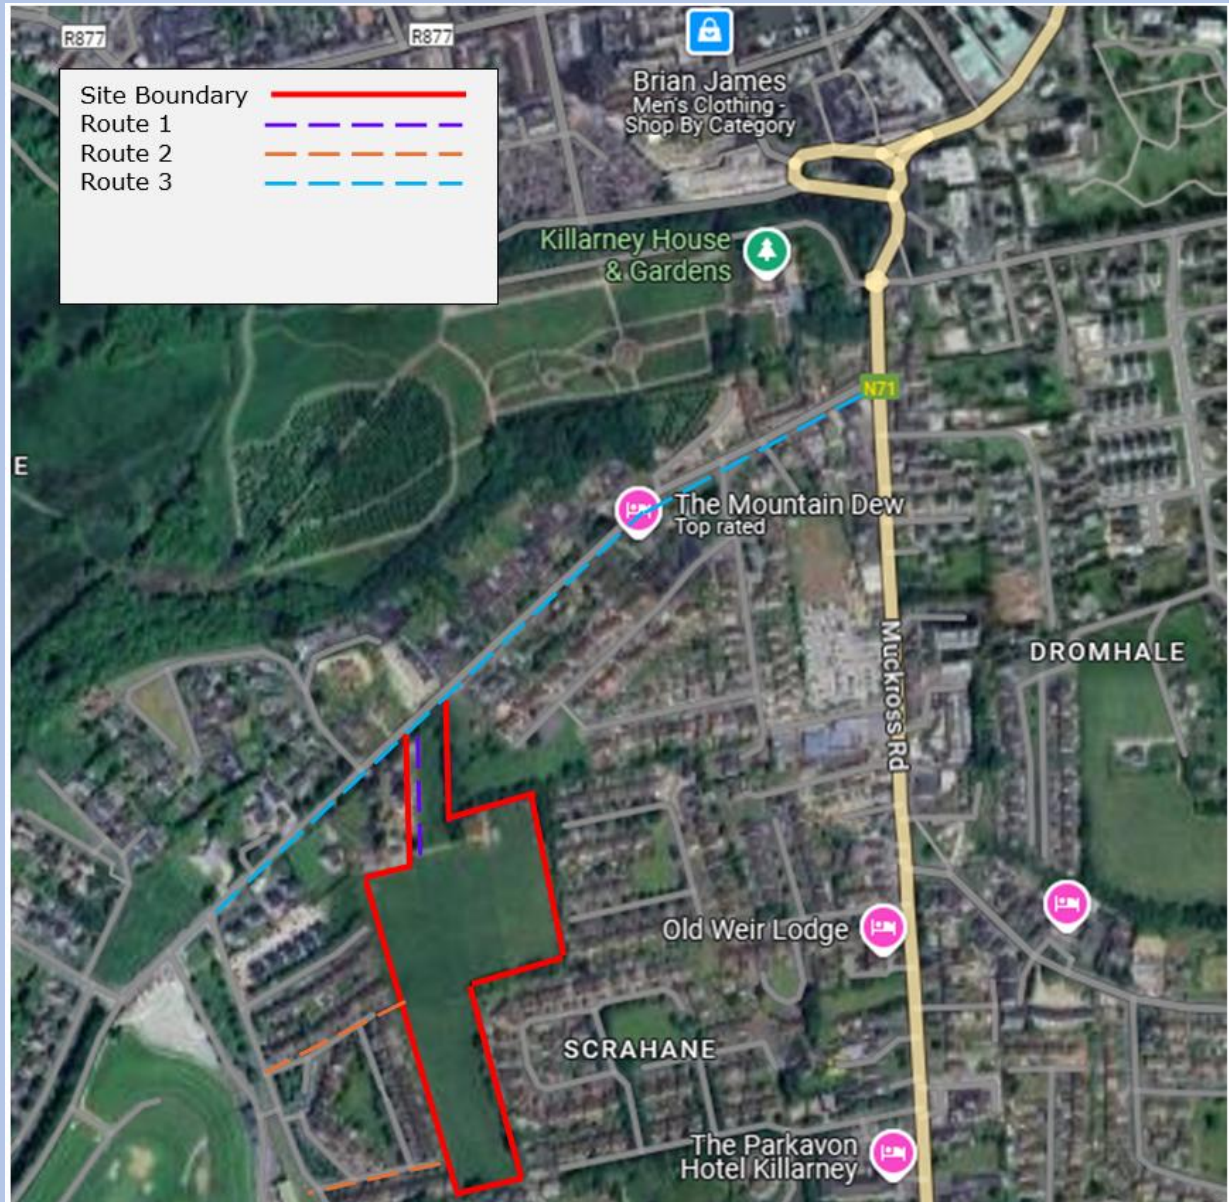
Route 3 begins at the entrance to Castle Falls (Flesk Cycle & Walking Facility) and passes the entrance of the site. Connecting to the local footpath network on Ross Road proceeding east before reaching the junction with Muckcross Road. The desire lines for this route are generally good with safety, security and quality of environment available along most of the route.

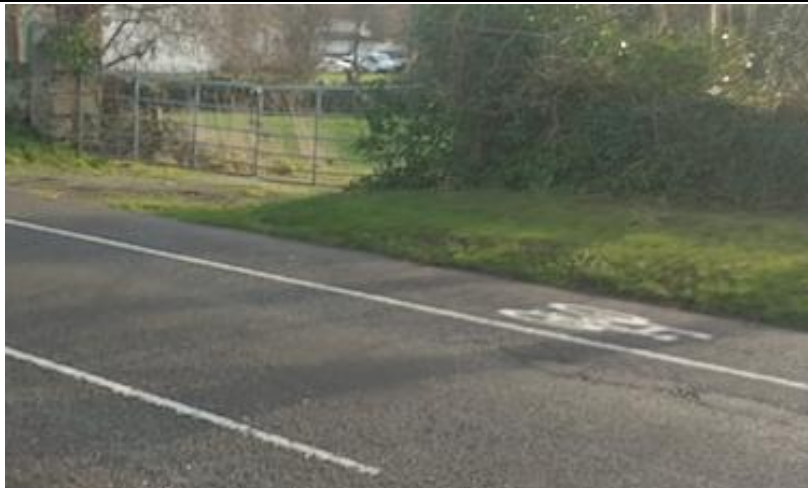
Figure 8.1 Photo Direction C

Issue: The southbound cycle lane is not provided with safety measure for any potential cyclists. No Northbound Cycle lane is provided along the route. This can cause collisions between cyclists and vehicles.

Recommendation: Provide a raised cycle Track through the new junction with the development.

Photo Ref	Route	Item	Mitigation	Reason/ Proposal
C	Route 3	Cycle lane unsafe with no footpath	Yes	Provide raised cycle facilities at the southbound of Ross Road to provide safety for the cyclists and to implement a footpath along the cycle lane to provide safety for the pedestrians.
D	Route 3	Northbound Footpath uneven	Yes	Resurface the footpath to ensure it is level and even.

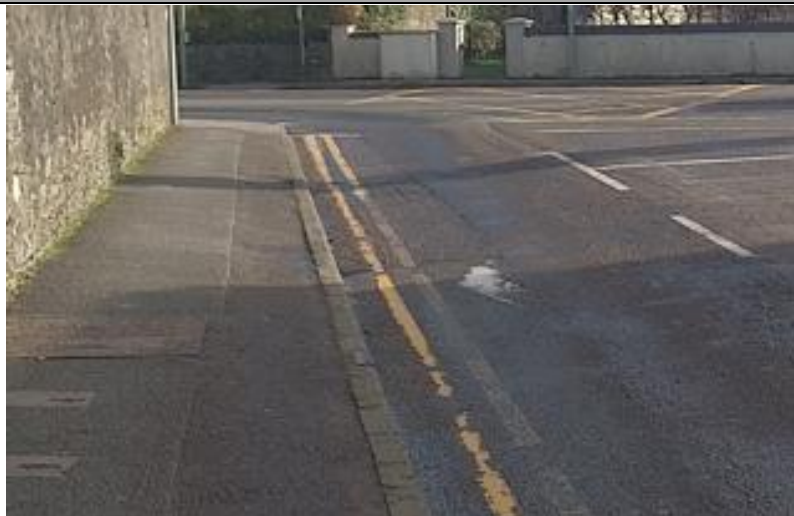
Figure 8.2 Photo Direction D

Issue: The current footpath that is on the northbound on Ross Road is uneven which may be a tripping hazard for wheelchair users and pedestrians.

Recommendation: Resurface the footpath to ensure that the footpath is even and safe for it to be used.
